# **AIRCRAFT ACCIDENT REPORT**

**CONTROLLED FLIGHT INTO TERRAIN  
AIR CHINA INTERNATIONAL FLIGHT 129  
B767-200ER, B2552  
MOUNTAIN DOTDAE, GIMHAE  
APRIL 15, 2002**

**KOREA MINISTRY OF CONSTRUCTION AND TRANSPORTATION  
KOREA AVIATION-ACCIDENT INVESTIGATION BOARD**

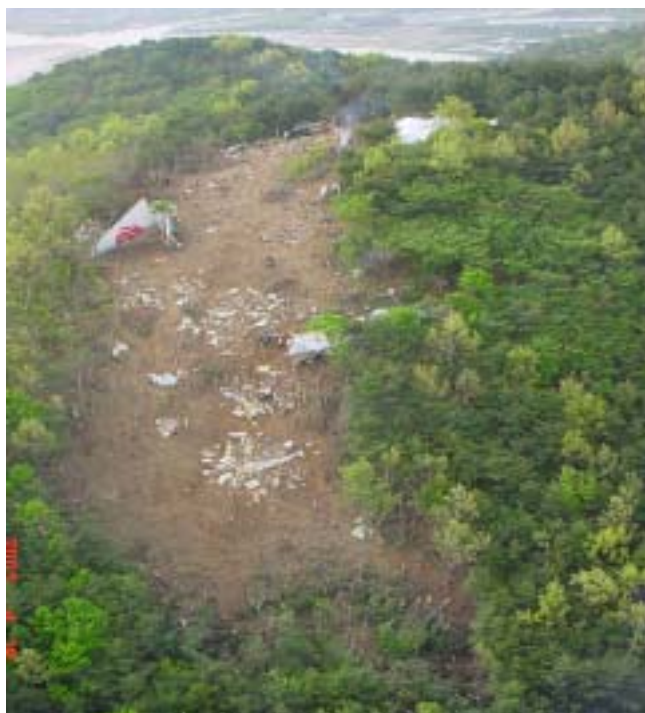
Figure 1-3 Site of Forest Damage

Damage to the forest on Mt. Dotdae of some 8,000 m<sup>2</sup>, including 12 grave sites, was caused by the aircraft's impact with trees and the ground, along with the spread of the wreckage.<sup>14</sup>

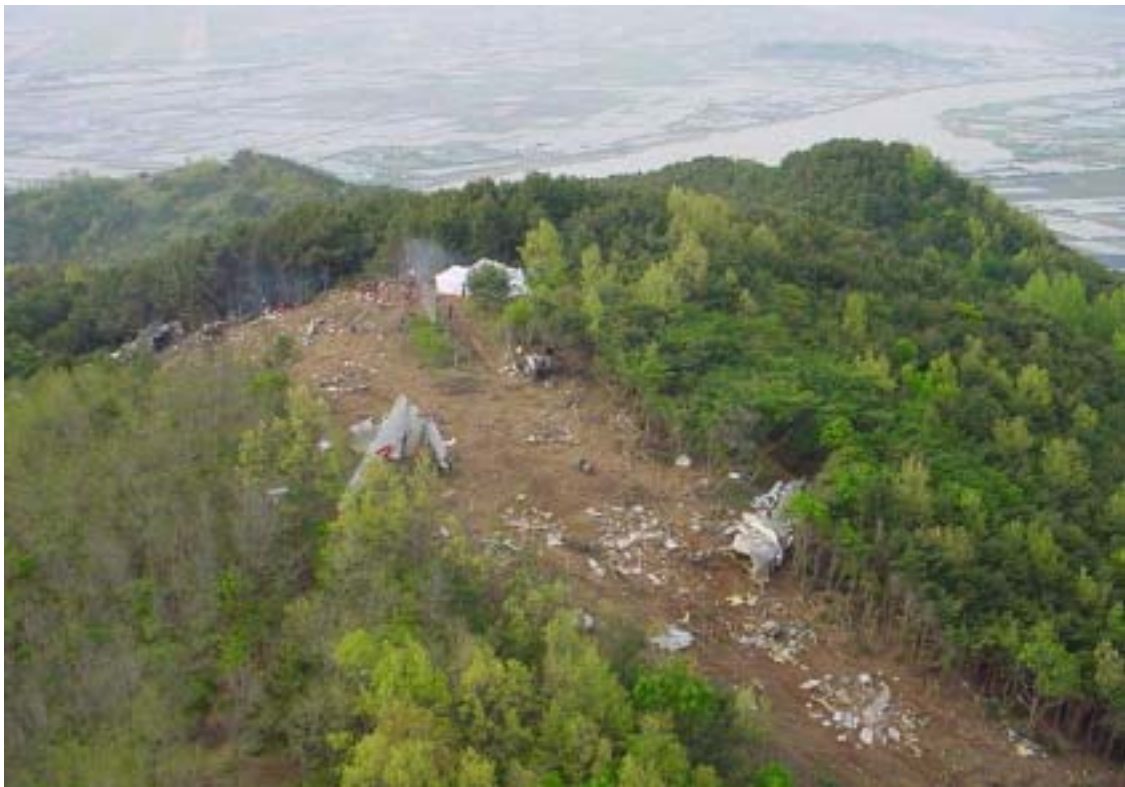
Figure 1-13 Photograph of the Accident Site

After the aircraft's impact with the ground, the right wing, empennage, left wing including parts of the fuselage, and two engines were separated respectively. The forward fuselage including the cockpit was totally consumed by a post impact ground fire.

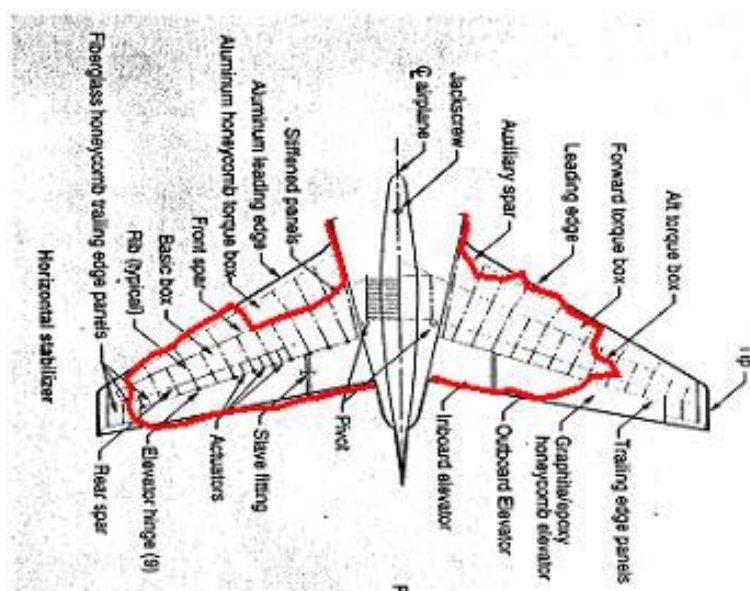
Figure 1-16 The Remaining Portion of the Wreckage (inner area of red line)

Both elevator tips were sheared off, with the elevators lying flat on the ground supporting the tail section upright.

The horizontal stabilizer's jackscrew extension was measured to be 14 inches between the lower gimbal assembly and the lower stop.

The front surface of the left horizontal stabilizer (as shown on Figure 1-16) was damaged and the tip was sheared off by an impact with the trees. While there were signs of the impact with trees on the front inner part of the left stabilizer, there was no sign of the preimpact skin corrosion or damage.

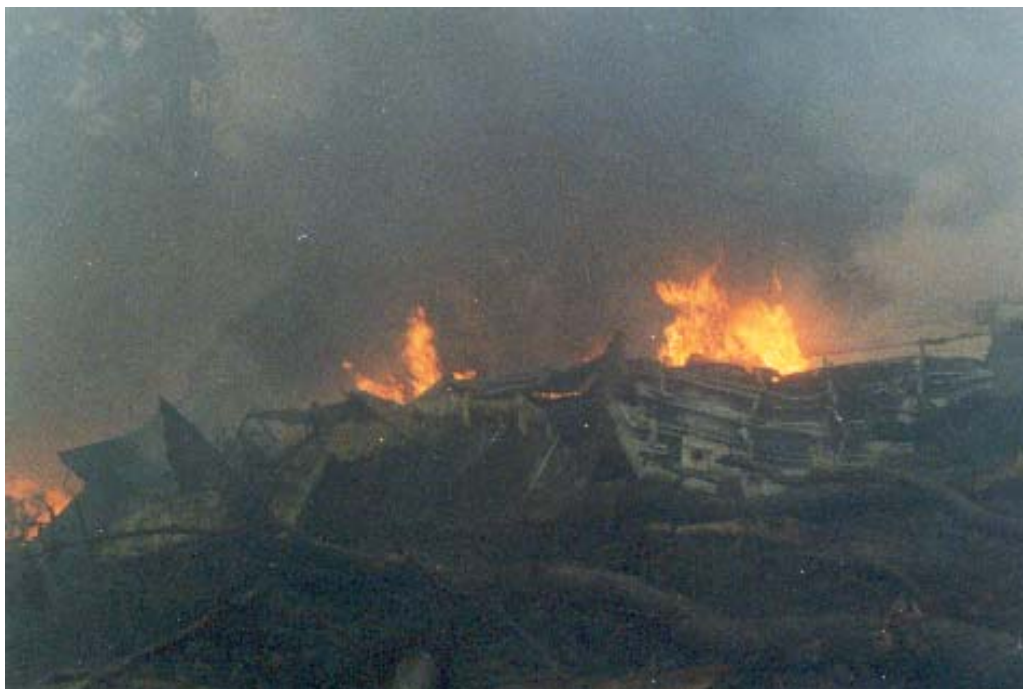
Figure 1-17 Photograph of the Aircraft on Fire after Crash

The on-scene investigation revealed no signs of fire on board the aircraft prior to crash. After the ground impact, the right wing and the empennage were separated from the fuselage. These items had no fire damage. The first sign of fire damage was found approximately 150 m from the initial point of impact.

At the accident site, it was raining with heavy fog. Fire fighters, soldiers and police struggled to apply dry chemical and halon fire extinguishing agents, and dirt to put out the fire, but the interiors of the cabin and flight deck were burnt completely, as shown on Figure 1-17. The fuselage fire, accompanied with exploding sounds and heavy smoke, was extinguished about 15:00 on the day of the accident.

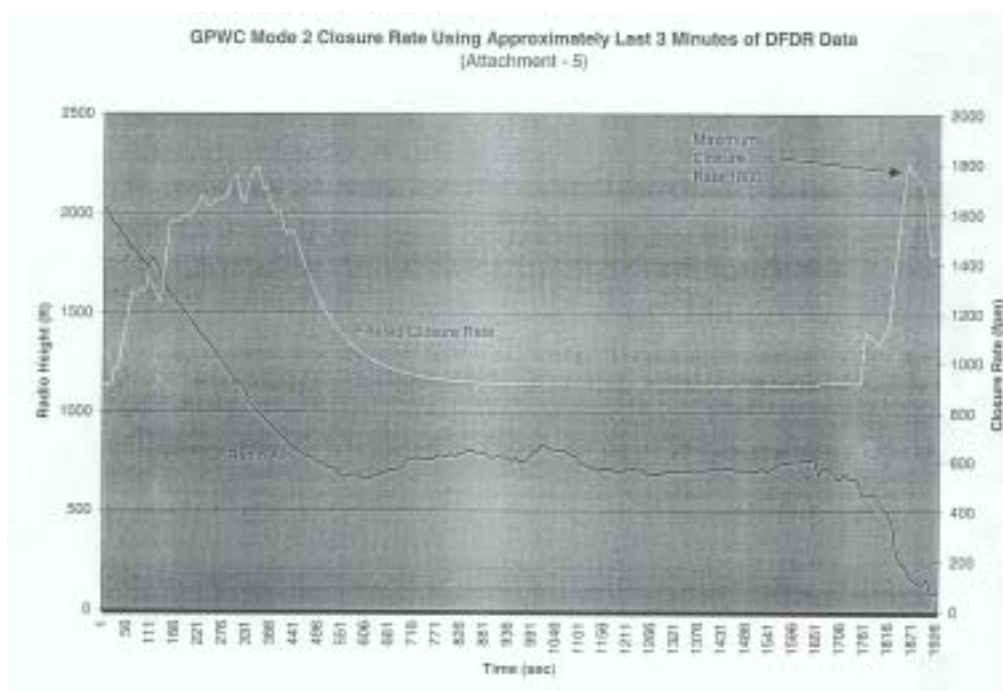
Figure 2-1: During the Last 3 Minutes of DFDR Data, GPWC Mode 2 Closure Rate

Flight 129 was descending, in the landing configuration with the landing gear and flaps down. At the time when the altitude was about 700 ft, it was approaching Mt. Dotdae at a speed of about 133 kt. This profile was less than the Mode 2 (Excessive Closure Rate), which should generate the warning of excessive closure to terrain.

According to a close examination<sup>177</sup> by Boeing of the radio altitude data of the FDR, the descent rate for the last 3 minutes from an altitude of 2000 ft until the ground impact increased from about 900 fpm to 1800 fpm, and at 700ft on the circling approach, it decreased to 900 fpm. It again increased to 1800 fpm just before the impact, as shown in the figure 2-1.

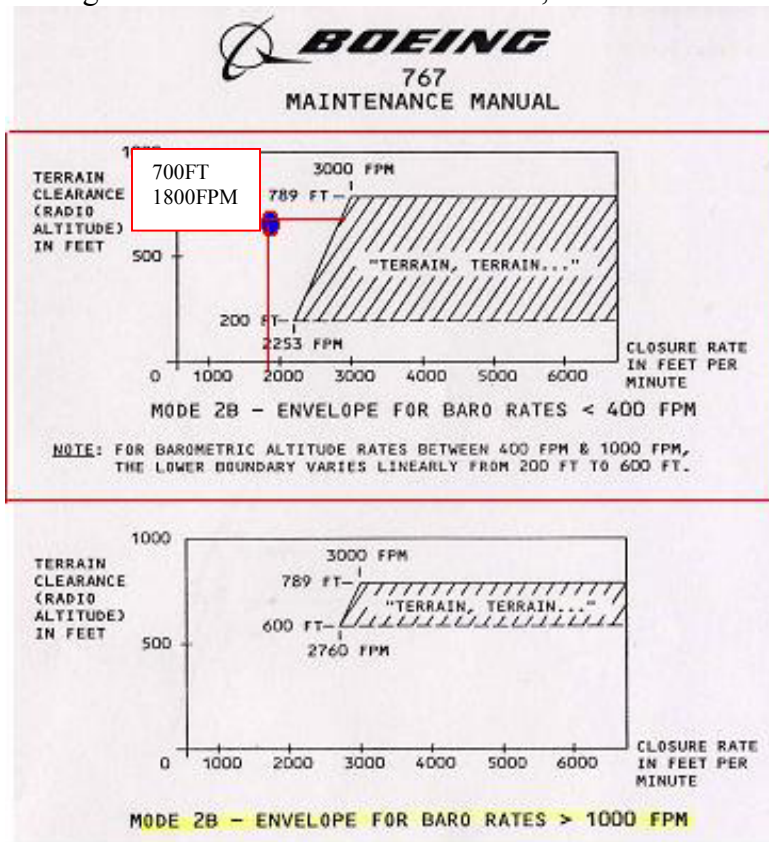
Figure 2-2 : Mode 2B Envelope for Barometric Rates < 400 FPM (Indication part)

The aircraft was in level flight and the baro rate was zero at the impact with Mt. Dotdae, which, as marked on the upper part of Figure 2-2, is applicable to Mode 2B-envelope for baro rate < 400 fpm. According to the Figure, when the closure rate is 2,253 fpm~3,000 fpm, Mode 2 warning will be generated per design. In the case of flight 129, the maximum closure rate was 1,800 fpm, which was outside the Mode 2B-envelope to generate the warning. Therefore, it was confirmed to be normal that the MK- III GPWC installed in the aircraft did not generate any warning.

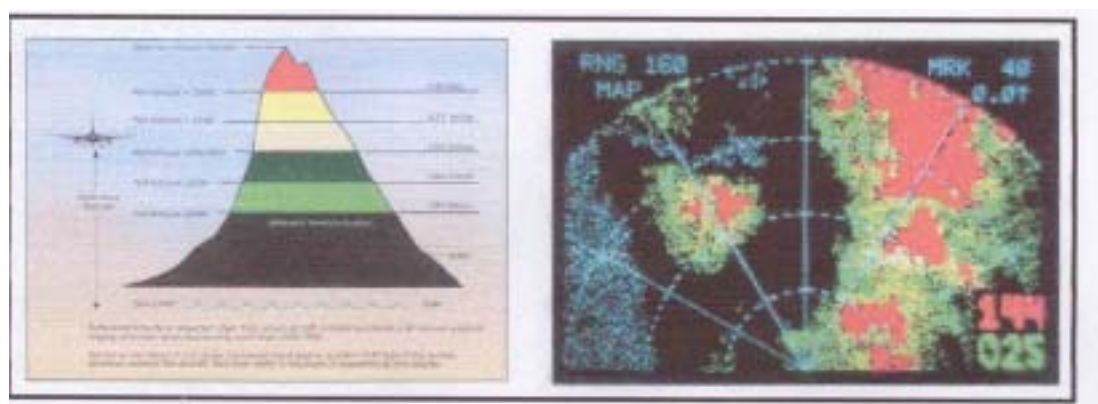
Through the Terrain Awareness Display (TAD) feature, EGPWS terrain information is displayed as visual and aural warning to the crew, as shown on Figure 2-4.

If the flight 129 aircraft had an EGPWS installed, it would have been a valuable tool to alert the flight crew about the approaching high terrain.
